# Protocols and Criteria for Acoustic Emission Monitoring of Fracture-Critical Steel Bridges

Minnesota  
Department of  
Transportation

Research Project  
Final Report 2015-36

The tied arch steel bridge that carries Minnesota State Highway 77 over the Minnesota River was selected for this project. This bridge is known as the Cedar Avenue Bridge (MnDOT #9600N). The advanced warning system was chosen to consist of commercially available monitoring equipment that detects the acoustic emission phenomenon as a structure is undergoing fracture. The purpose of choosing to monitor the Cedar Avenue Bridge is not because the bridge is thought to be unsafe or susceptible to fatigue cracking. The Cedar Avenue Bridge has not experienced any known cracking in its lifetime. The bridge was chosen to serve as a platform on which to develop, implement, and test the monitoring technology. This report documents the collection of data to insure the adequate operation of the system and the development of data analysis procedures for use on data collected from the Cedar Avenue Bridge.

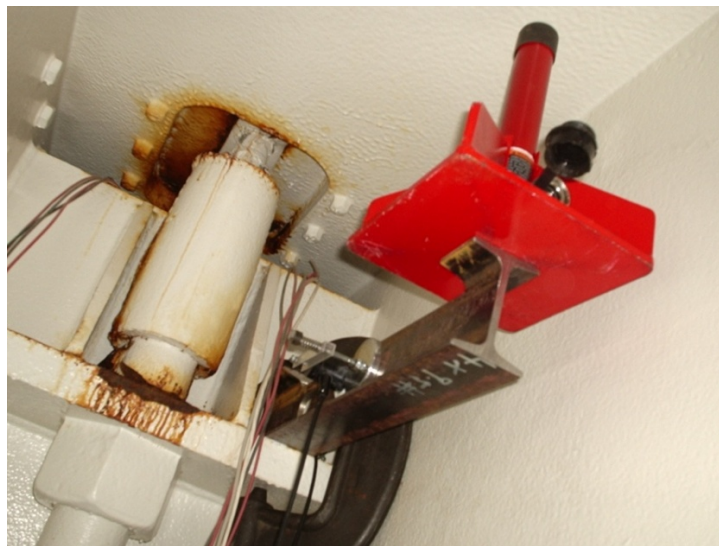
The beam location allowed for 12.9" of free space between the notched beam and the ceiling (top flange of tie girder). An 11" tall hydraulic jack was placed with its supporting base on the beam and oriented so the cylinder jacking action was against the ceiling. For the first set of tests Velcro® was used to secure the jack to the beam in order to hold the jack in place before and after loading. For the second set of tests the jack was manually held in place until the jacking force created enough friction to hold it in place for the tests.

**Figure 6.2: Field setup for notched beam test**

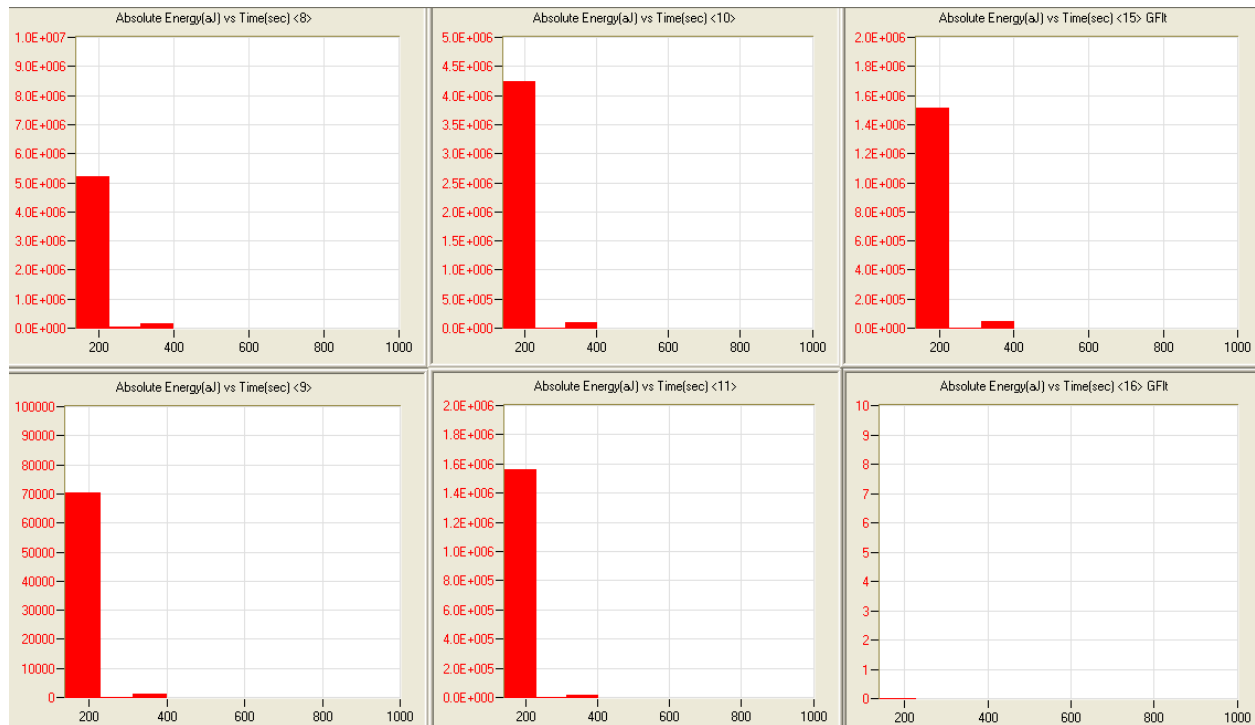
**Figure A.54: Absolute energy rate [aJ/s] during 86 second period including fracture (individual sensors)**
